DEPARTMENT OF FLEET & FACILITY MANAGEMENT

PA Railroad – Wallace/57th/58th Streets as Potential Urban Agriculture Opportunity Sites Summary of Environmental Reports

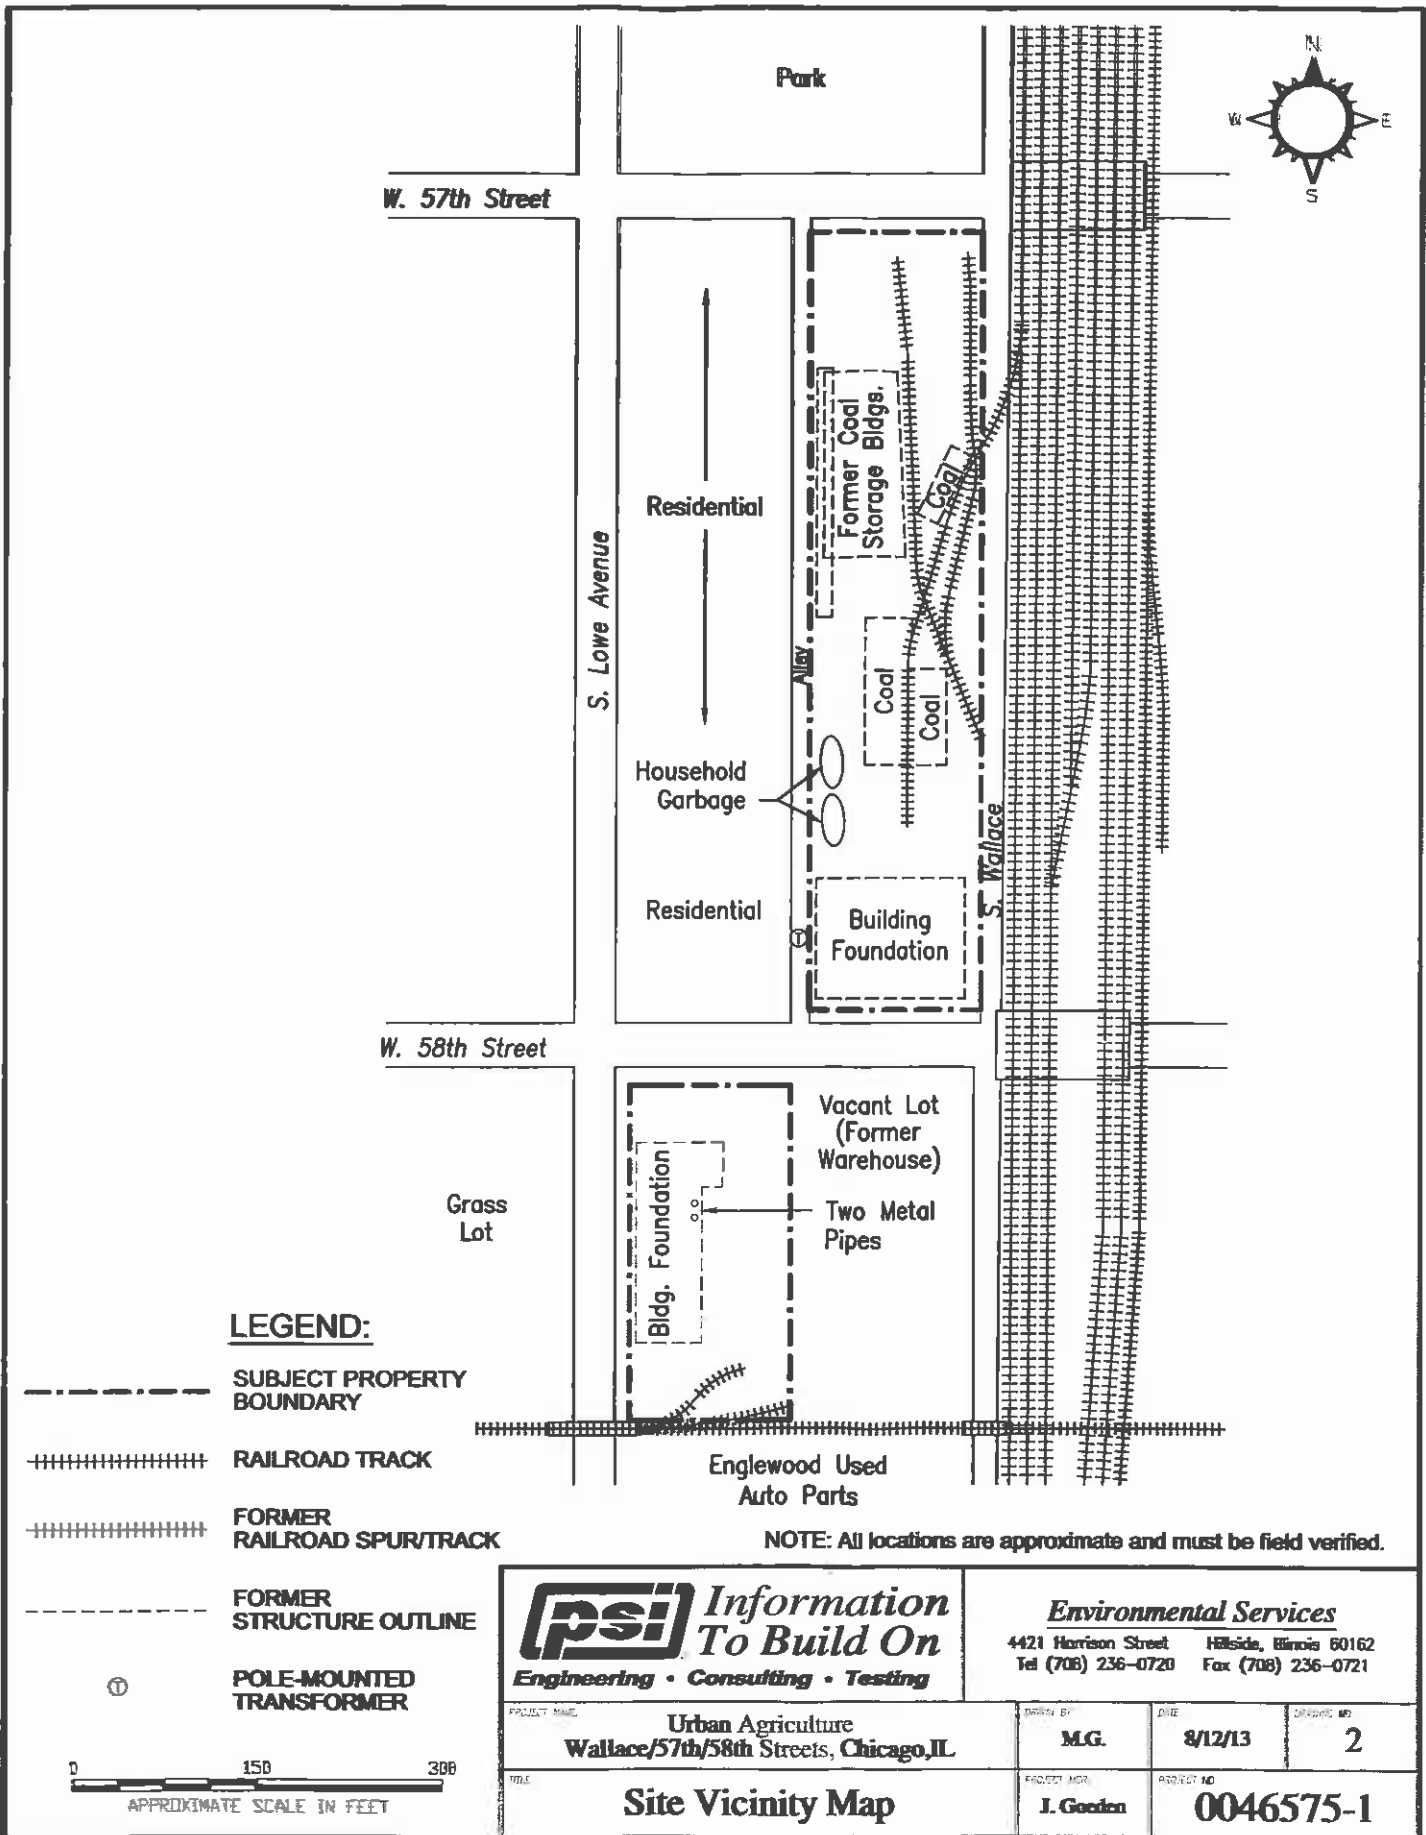
Household Garbage

Former Coal Storage Bldgs.

Building Foundation

Bldg. Foundation

Vacant Lot (Former Warehouse)

Two Metal Pipes
